**Subsidence Documentation Study**  
**Sufco Mine**  
**May 30, 2003**  
**Summary**

The data contained in this binder is a compilation of subsidence features gathered in the field from the 19 of May to the 22 of May 2003. The features have been organized into five different sections representing panels in descending order starting with the most recent. At the beginning of each section is a summary sheet outlining important aspects of the panel with emphasis on subsidence features contained therein.

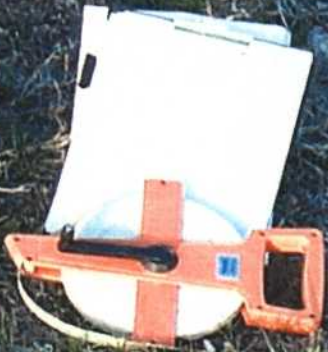
Dimensions (in feet): This is a series of five parallel cracks all oriented the same way. Their lengths vary from between 40 and 90 feet long, and all are between 1 and 3 inches wide. They are spaced approximately 50 feet apart.

**Other Comments** (seeps, stream channel, archeological, eagle nest) **and**  
**Recommendations** (needs work, healing, leave alone, watch?):  
All cracks are healing pretty well.

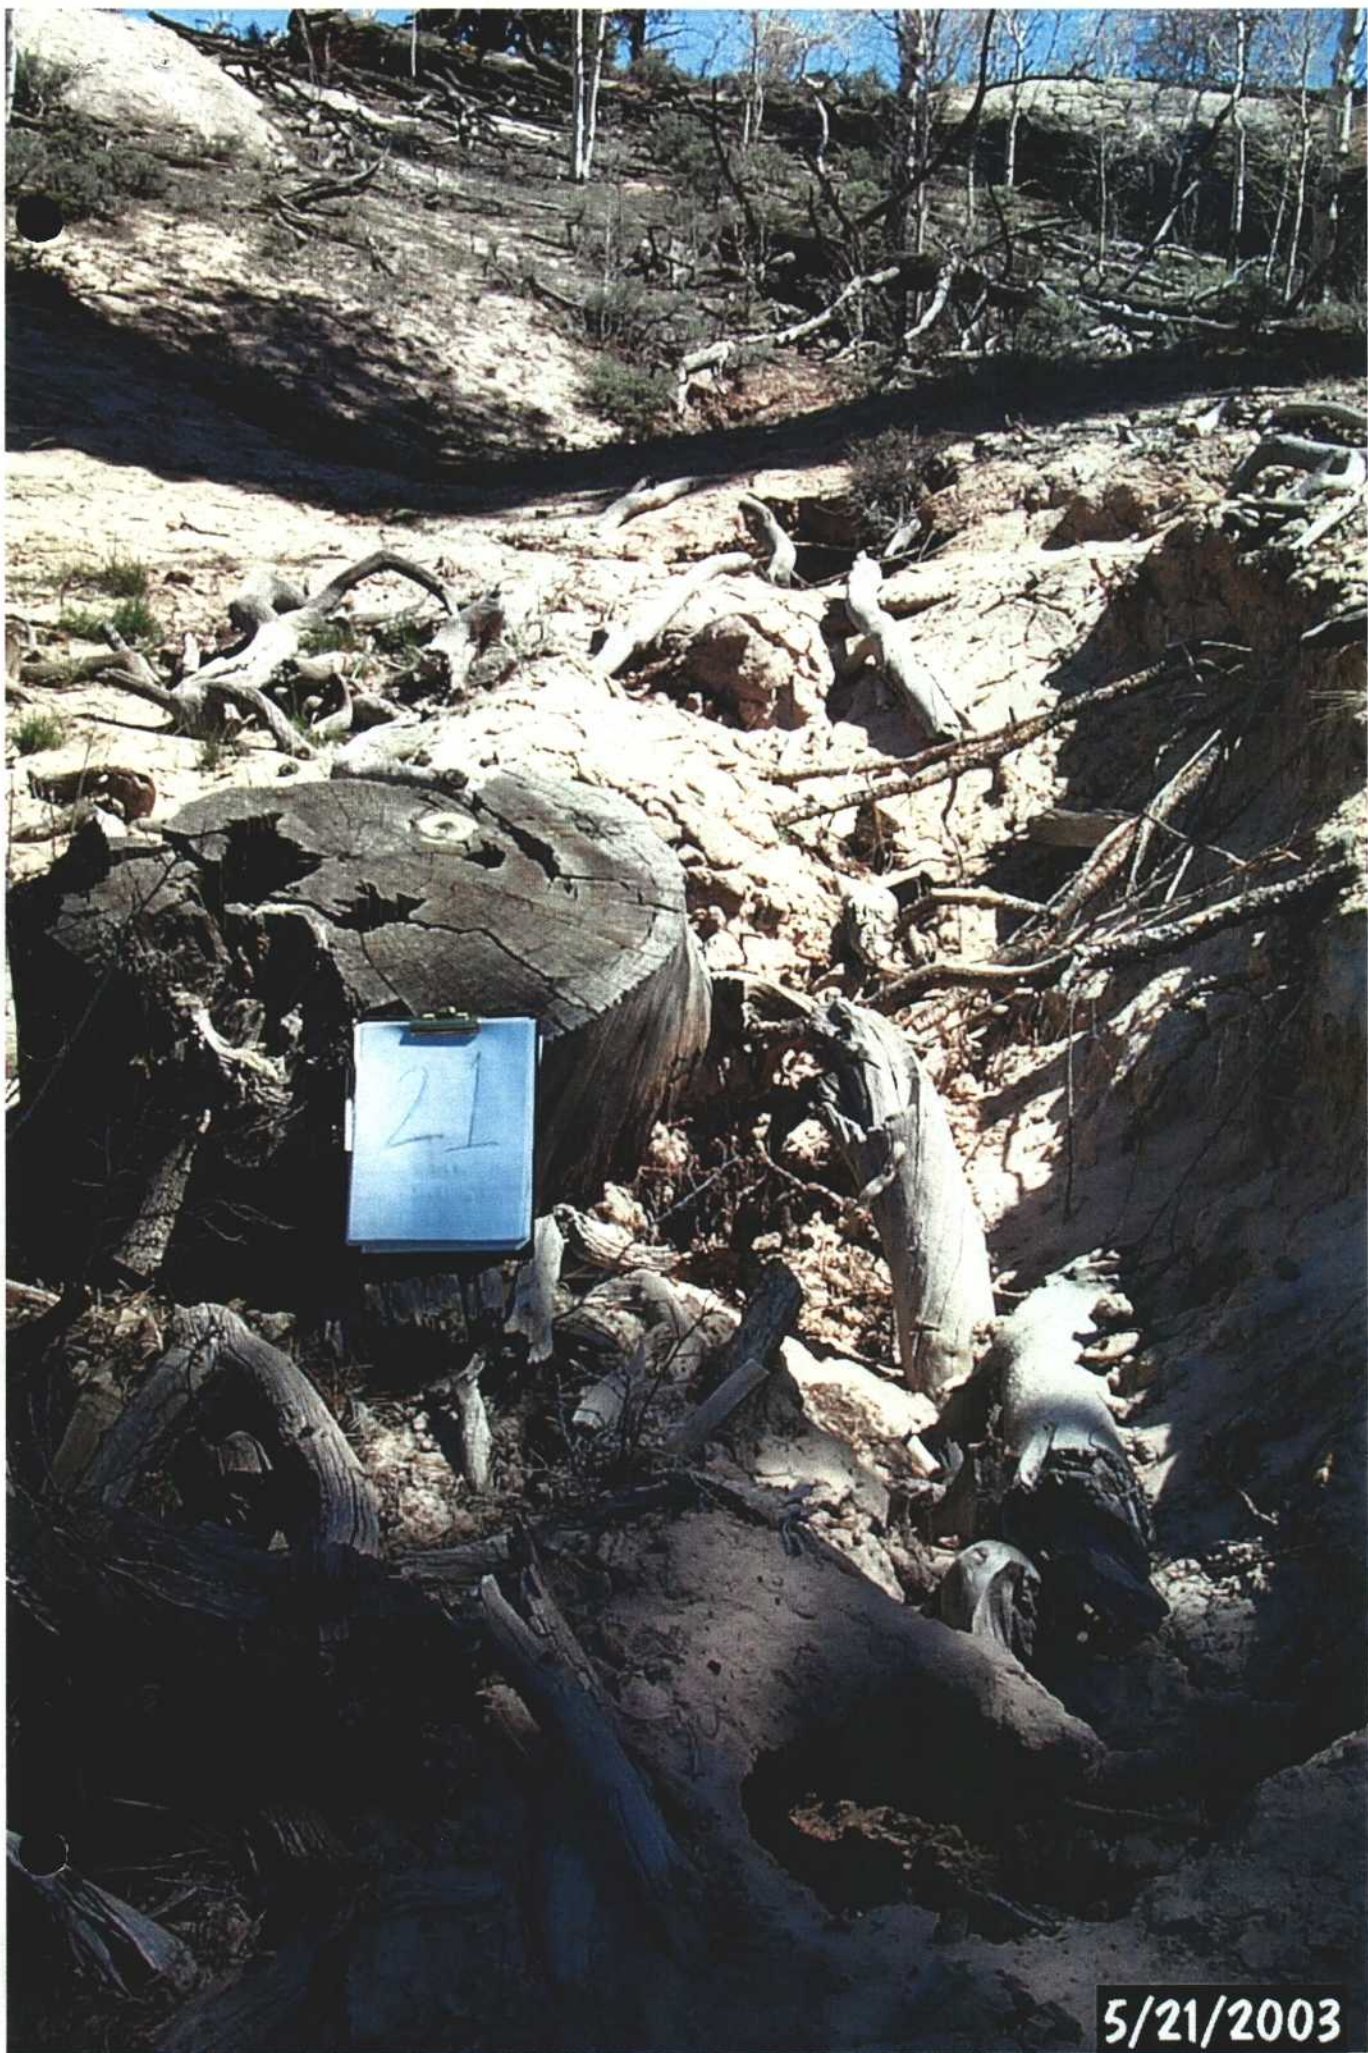
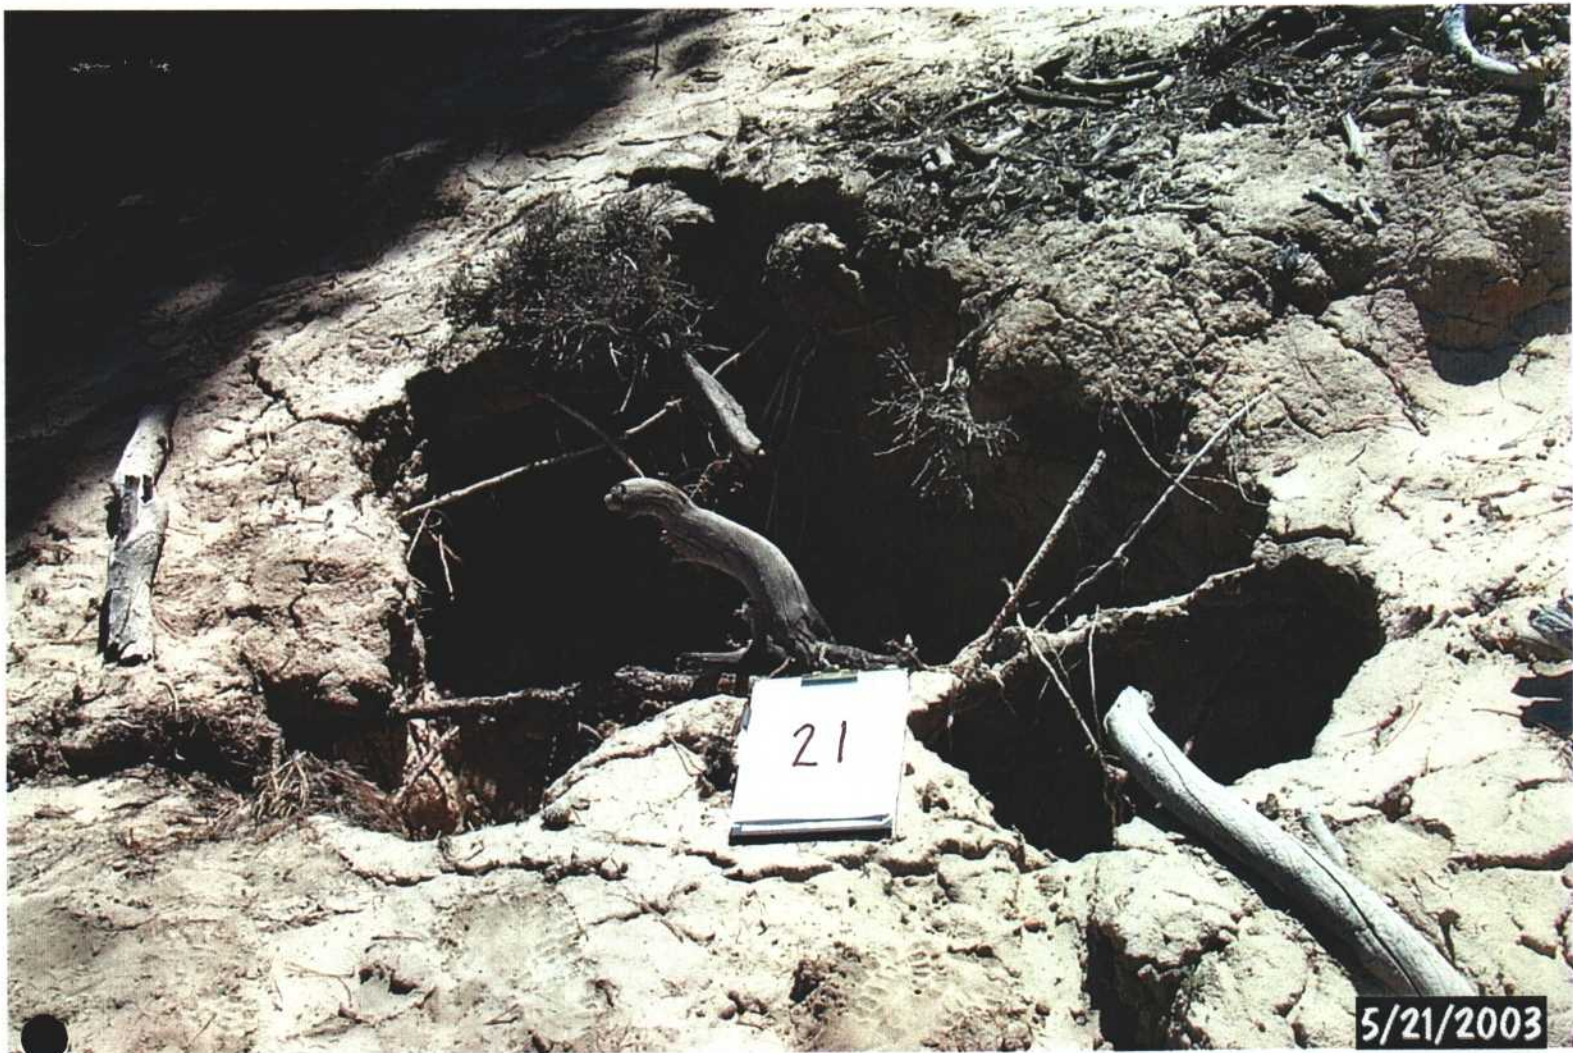
Dimensions (in feet): This crack is 99 feet long, up to 5 feet wide, and up to four feet deep.

Potential Hazards? This crack cuts through a game trail, and may be a hazard to cattle.

Taking into consideration the crack's dimensions versus how long it has had to heal I would recommend possibly mitigating this one.

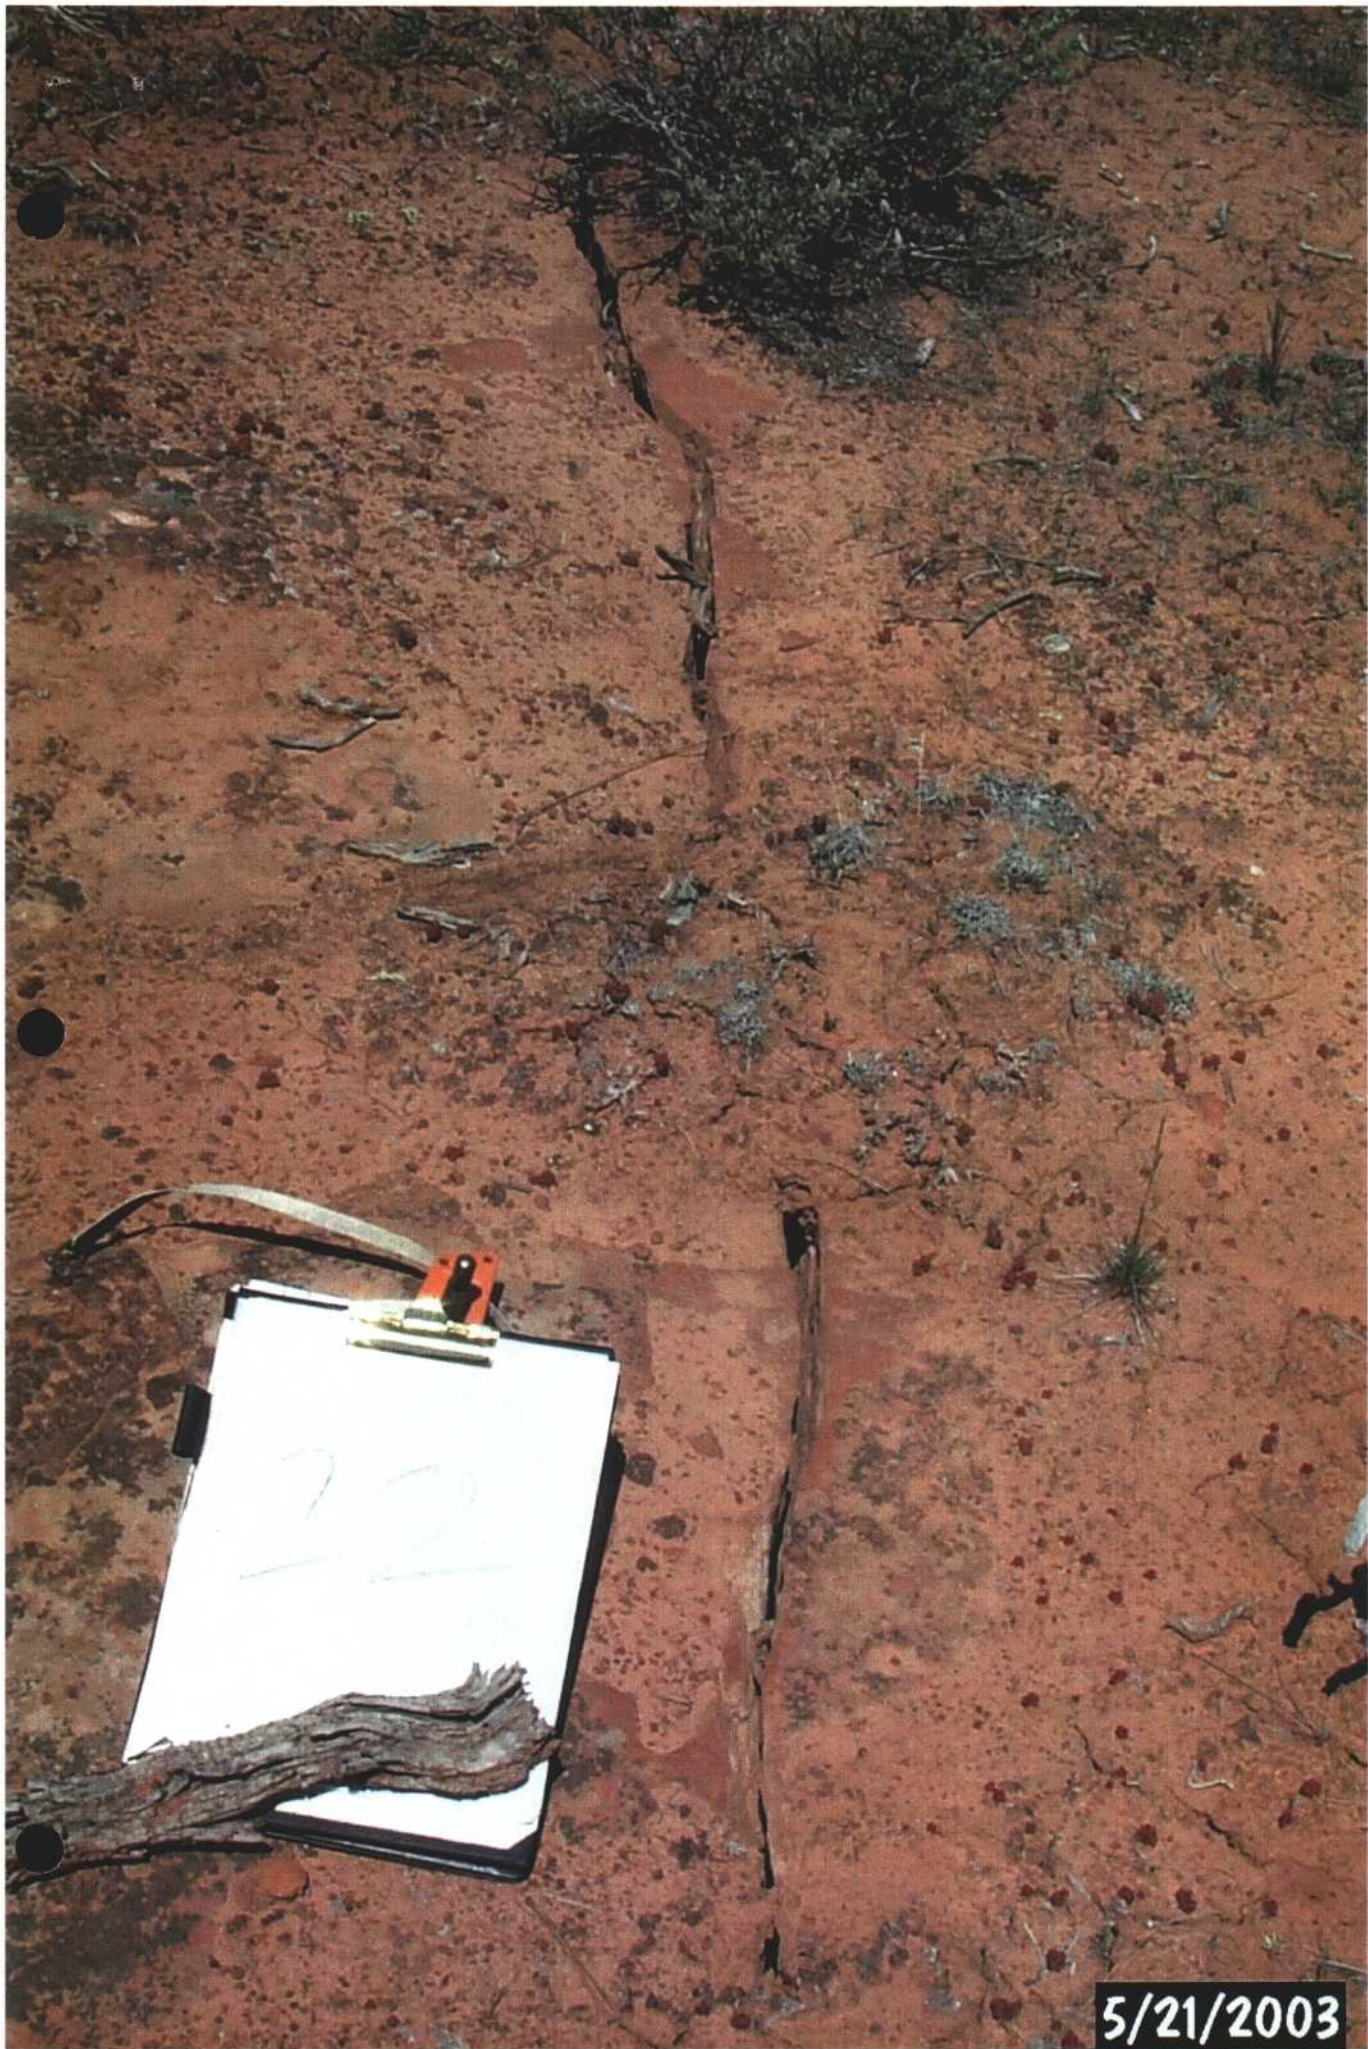
Dimensions (in feet): This crack is 12 feet long, up to 1 inch wide.

Other Comments (seeps, stream channel, archeological, eagle nest) and  
Recommendations (needs work, healing, leave alone, watch?):  
This crack is the largest of several cracks in this area that are  
healing well.

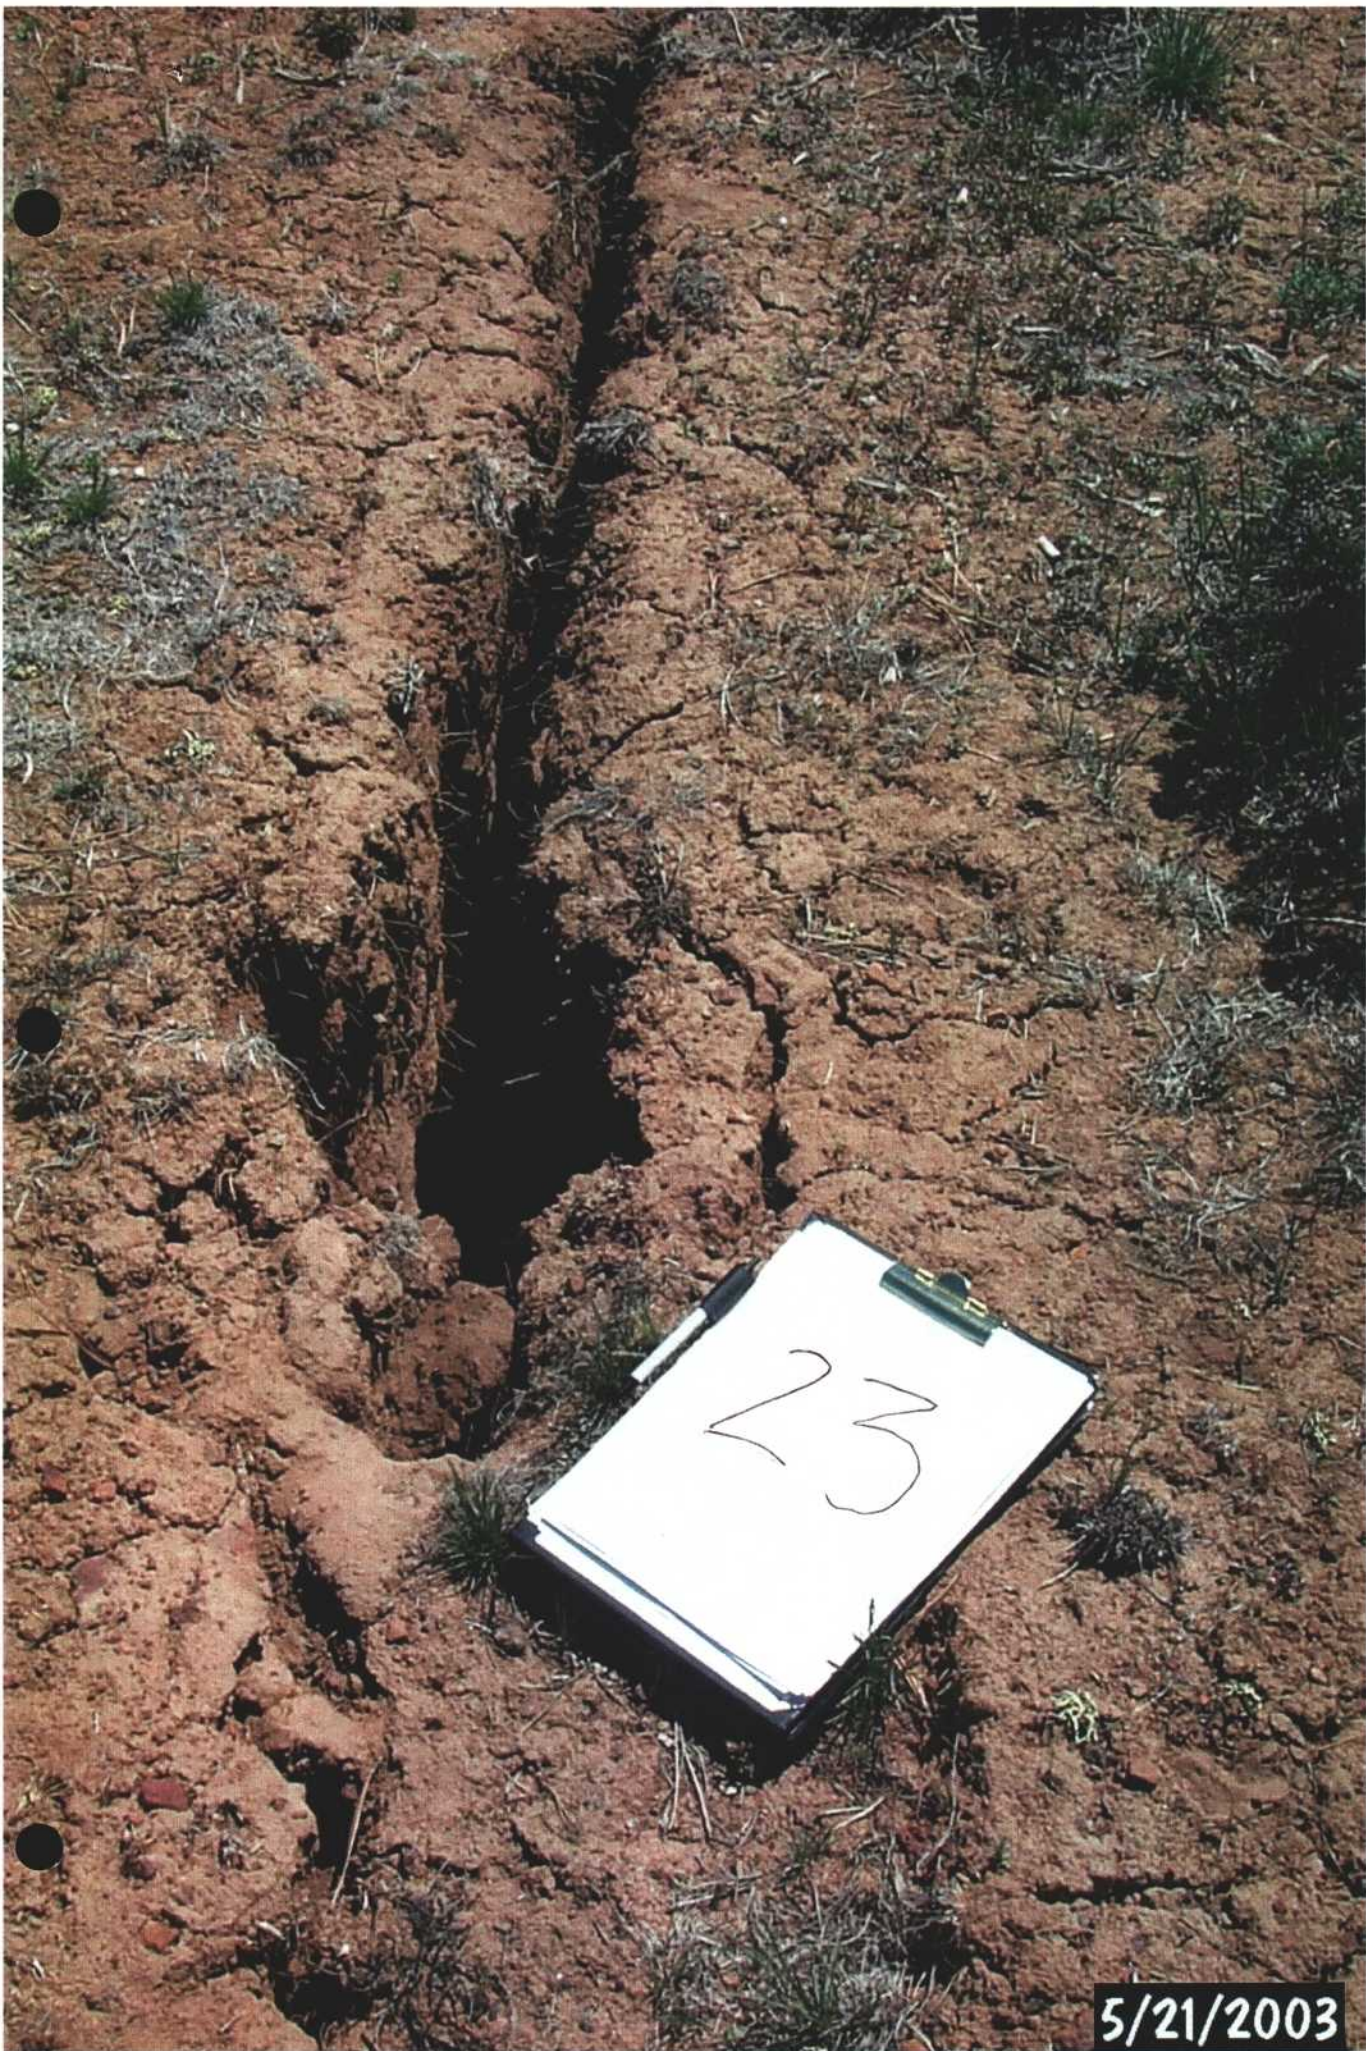
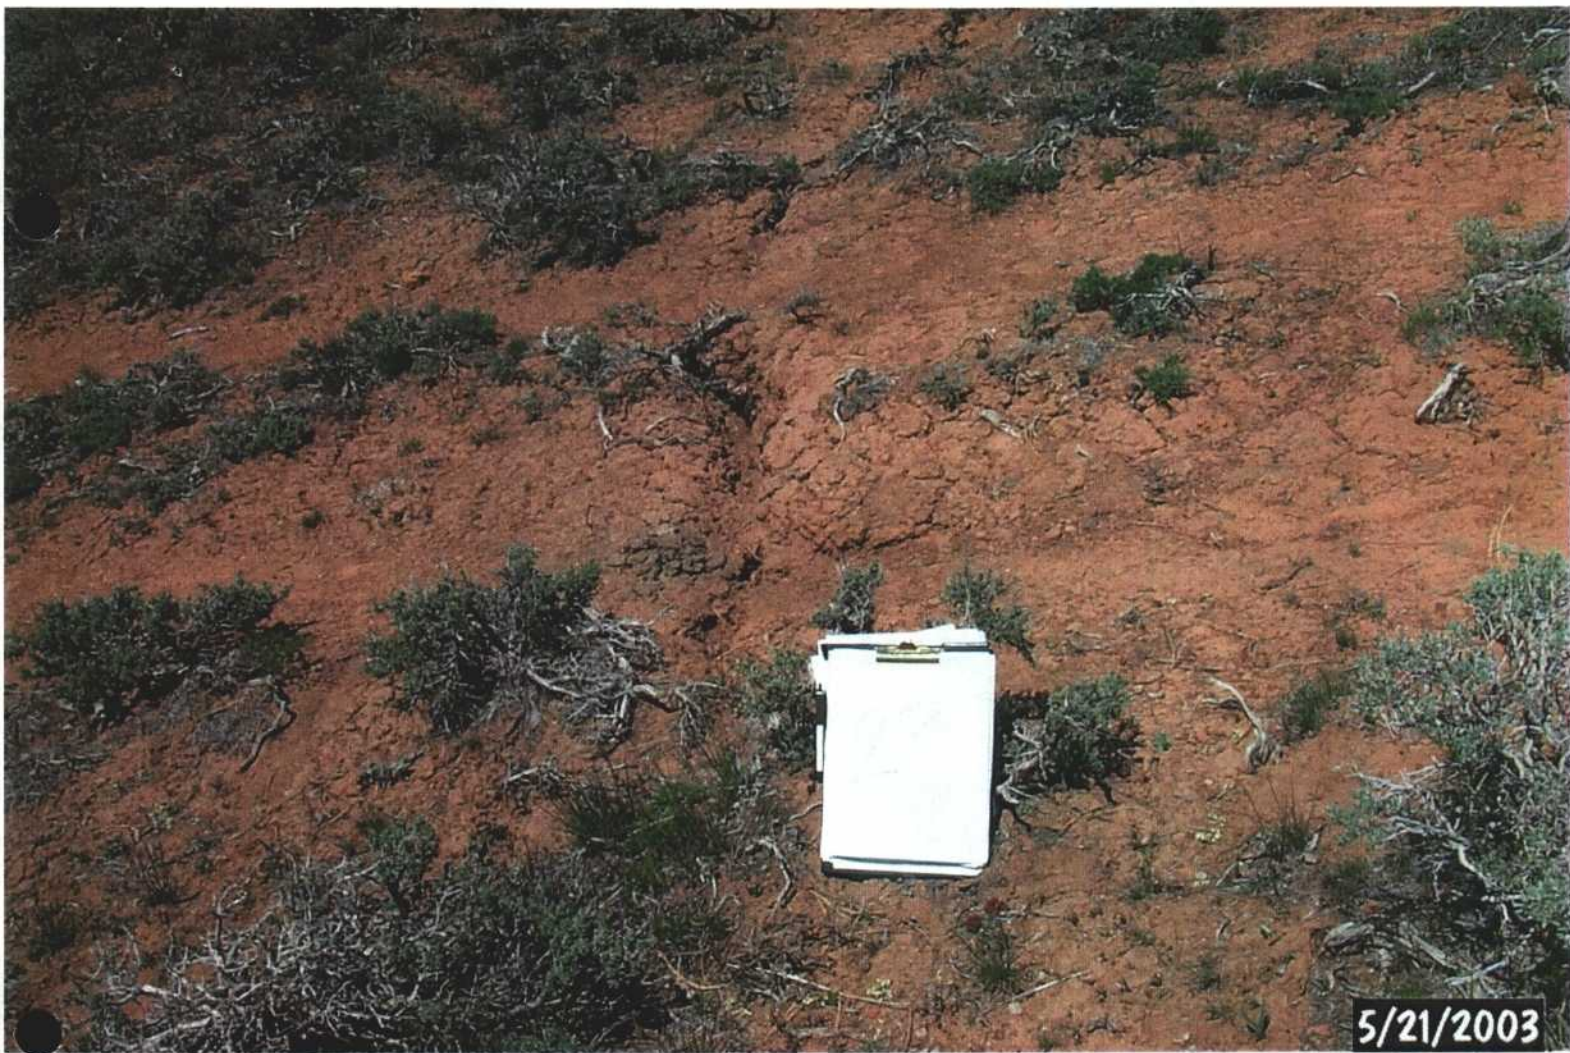
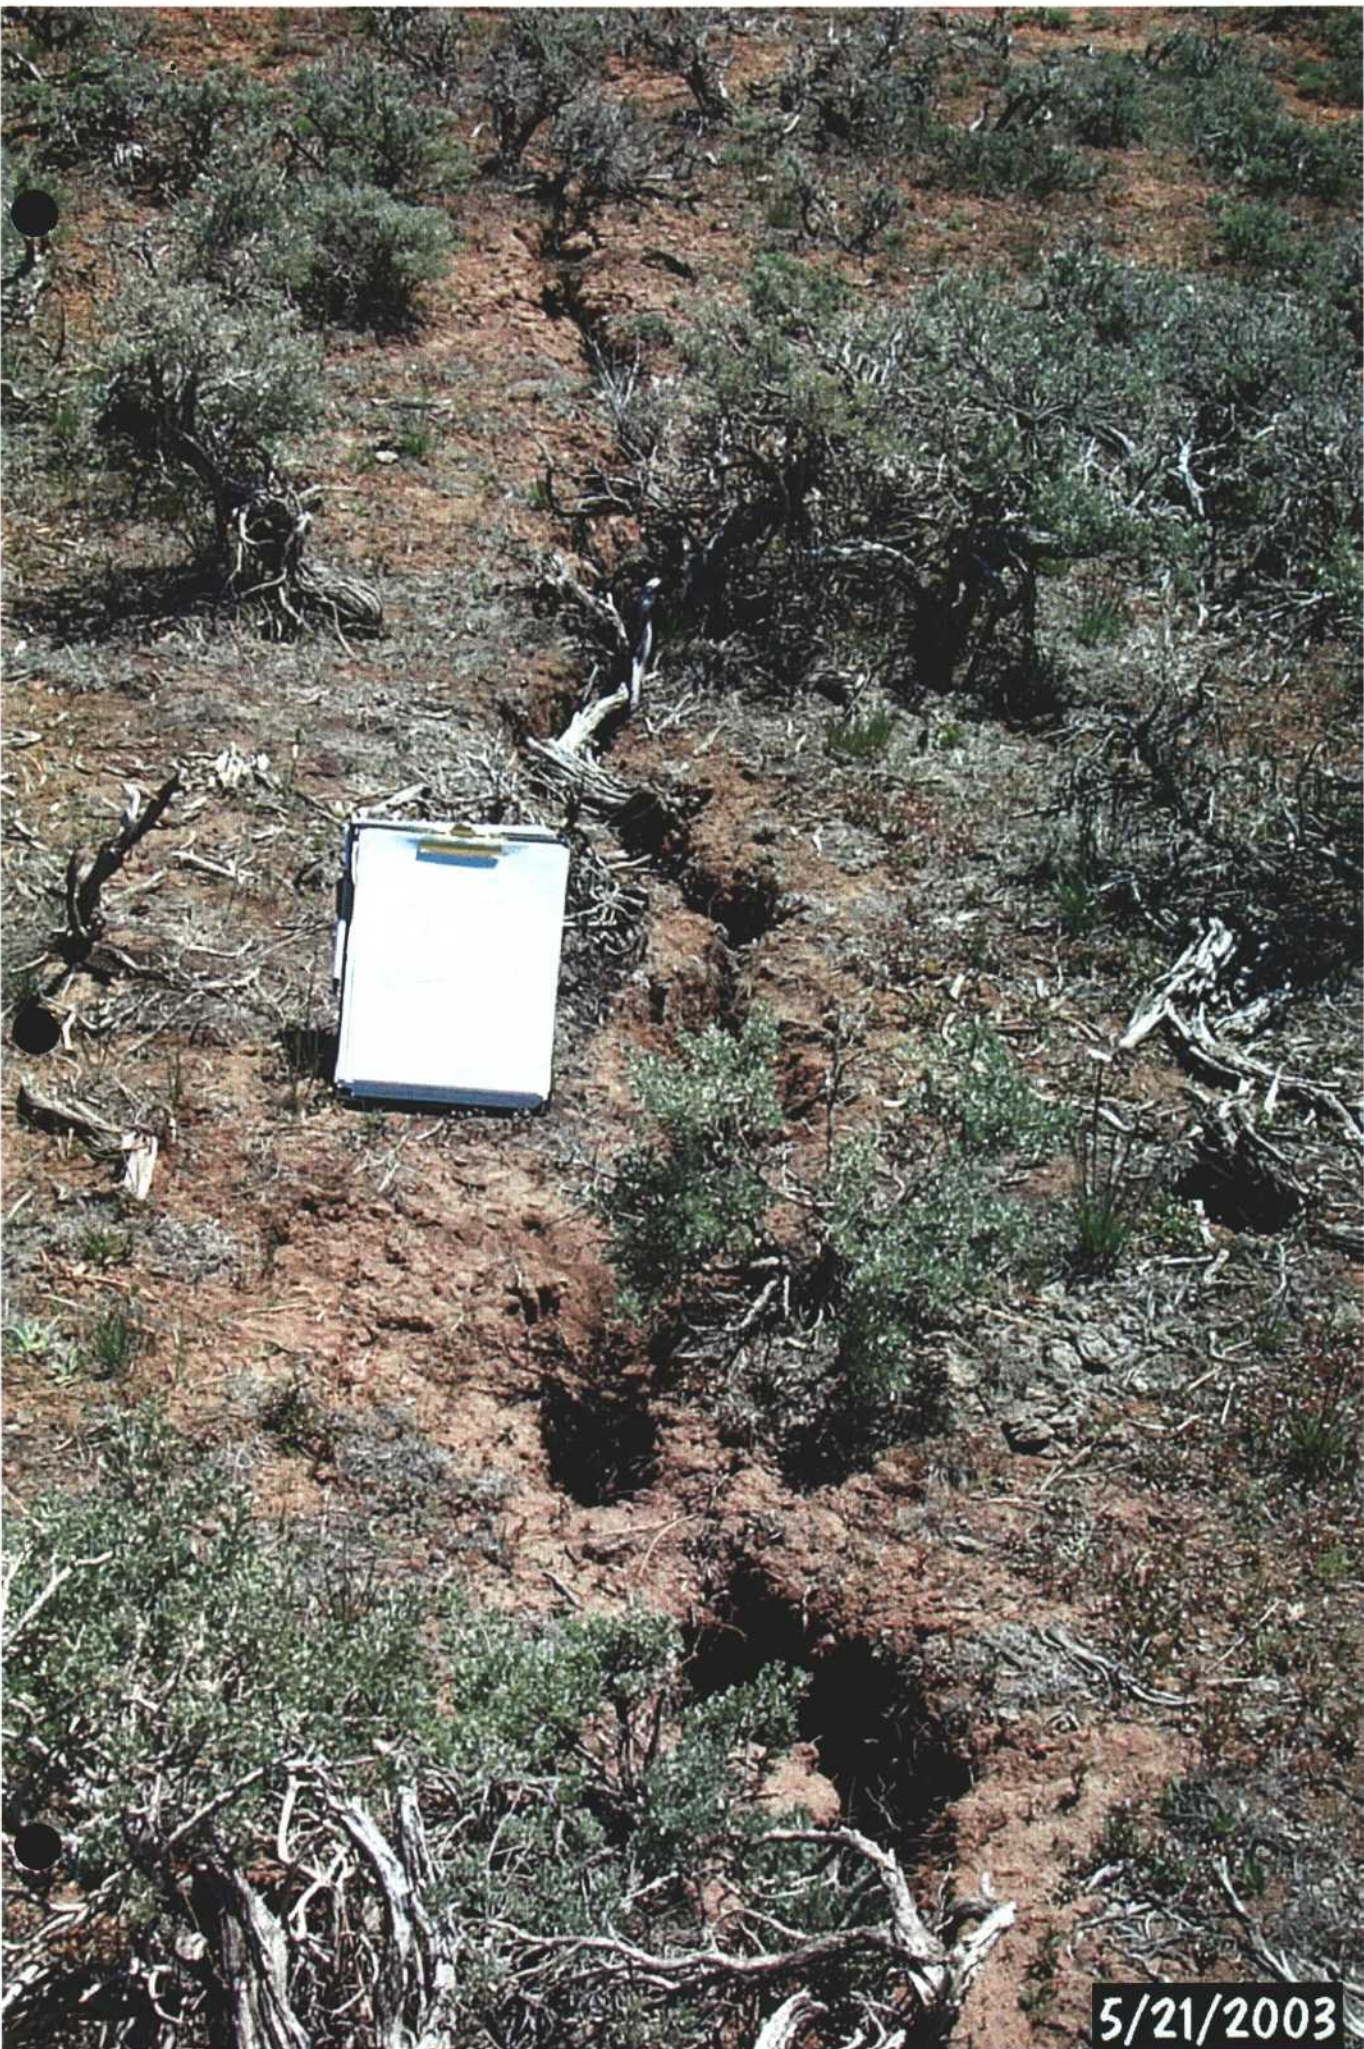
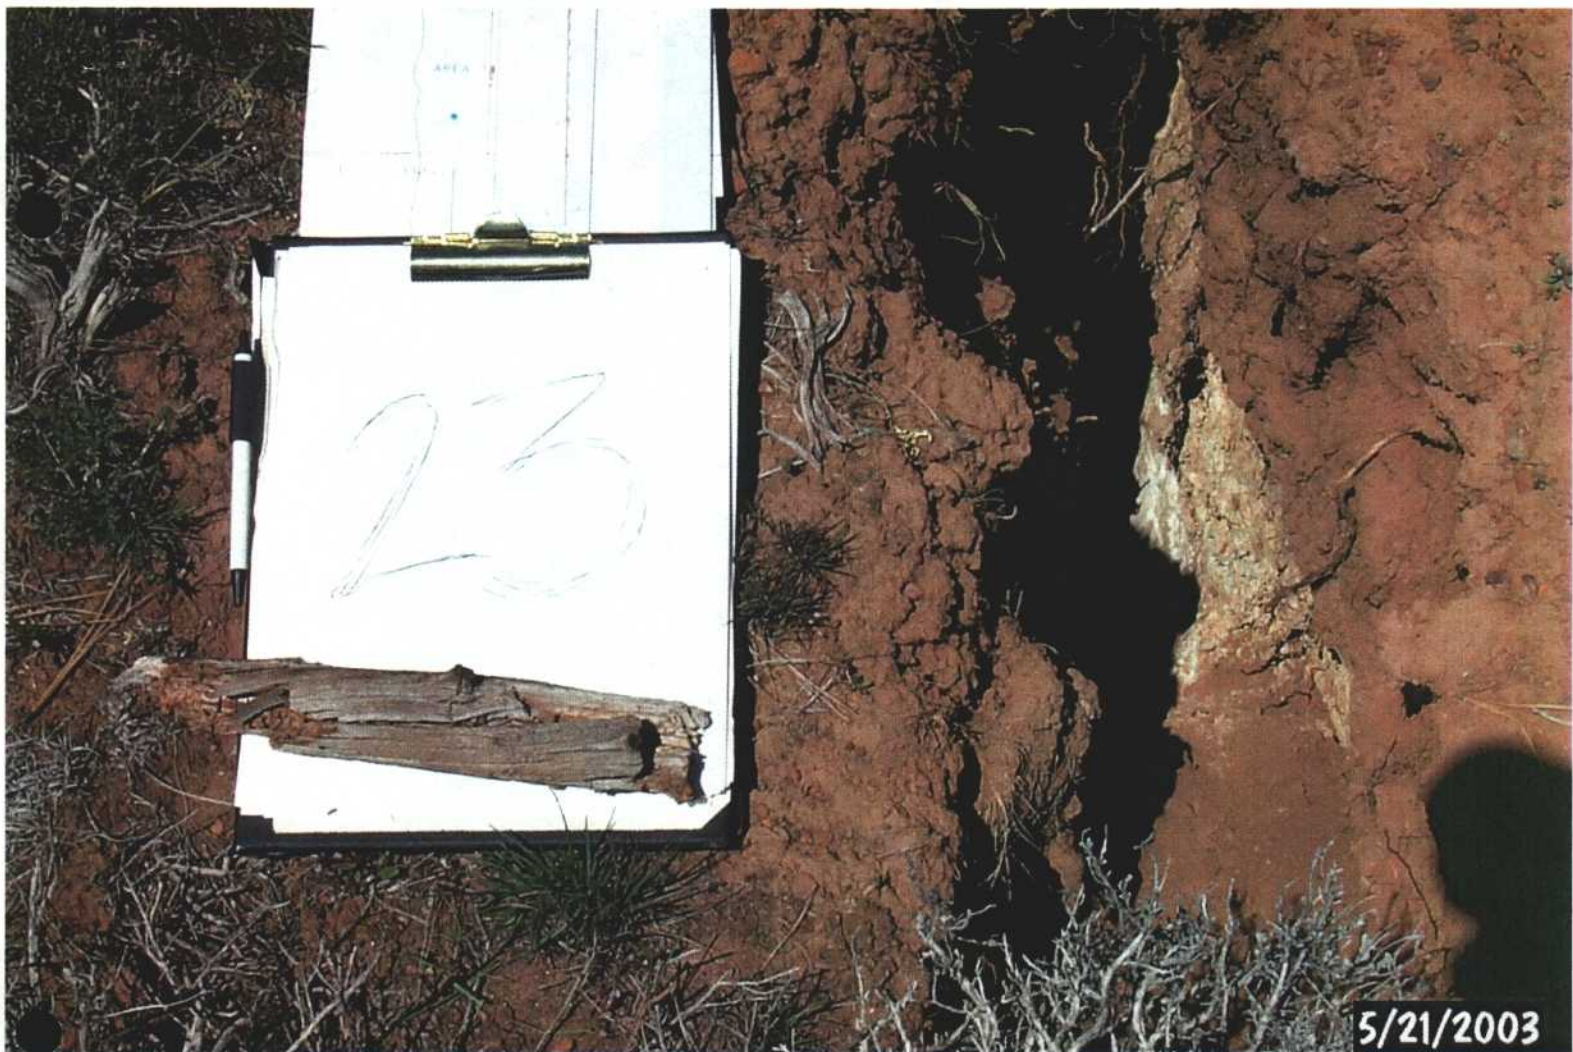
**Dimensions (in feet):** This crack is 183 feet long, up to 11 inches wide, and appears quite deep.

**Potential Hazards?** This is a very deep crack visibly – it could swallow dirt for a long time and not heal. A potential hazard to cattle.

crack is large enough to reveal underlying bedrock

This crack runs through a dirt road. Taking into consideration the crack's dimensions versus how long it has had to heal I would recommend mitigating this one.

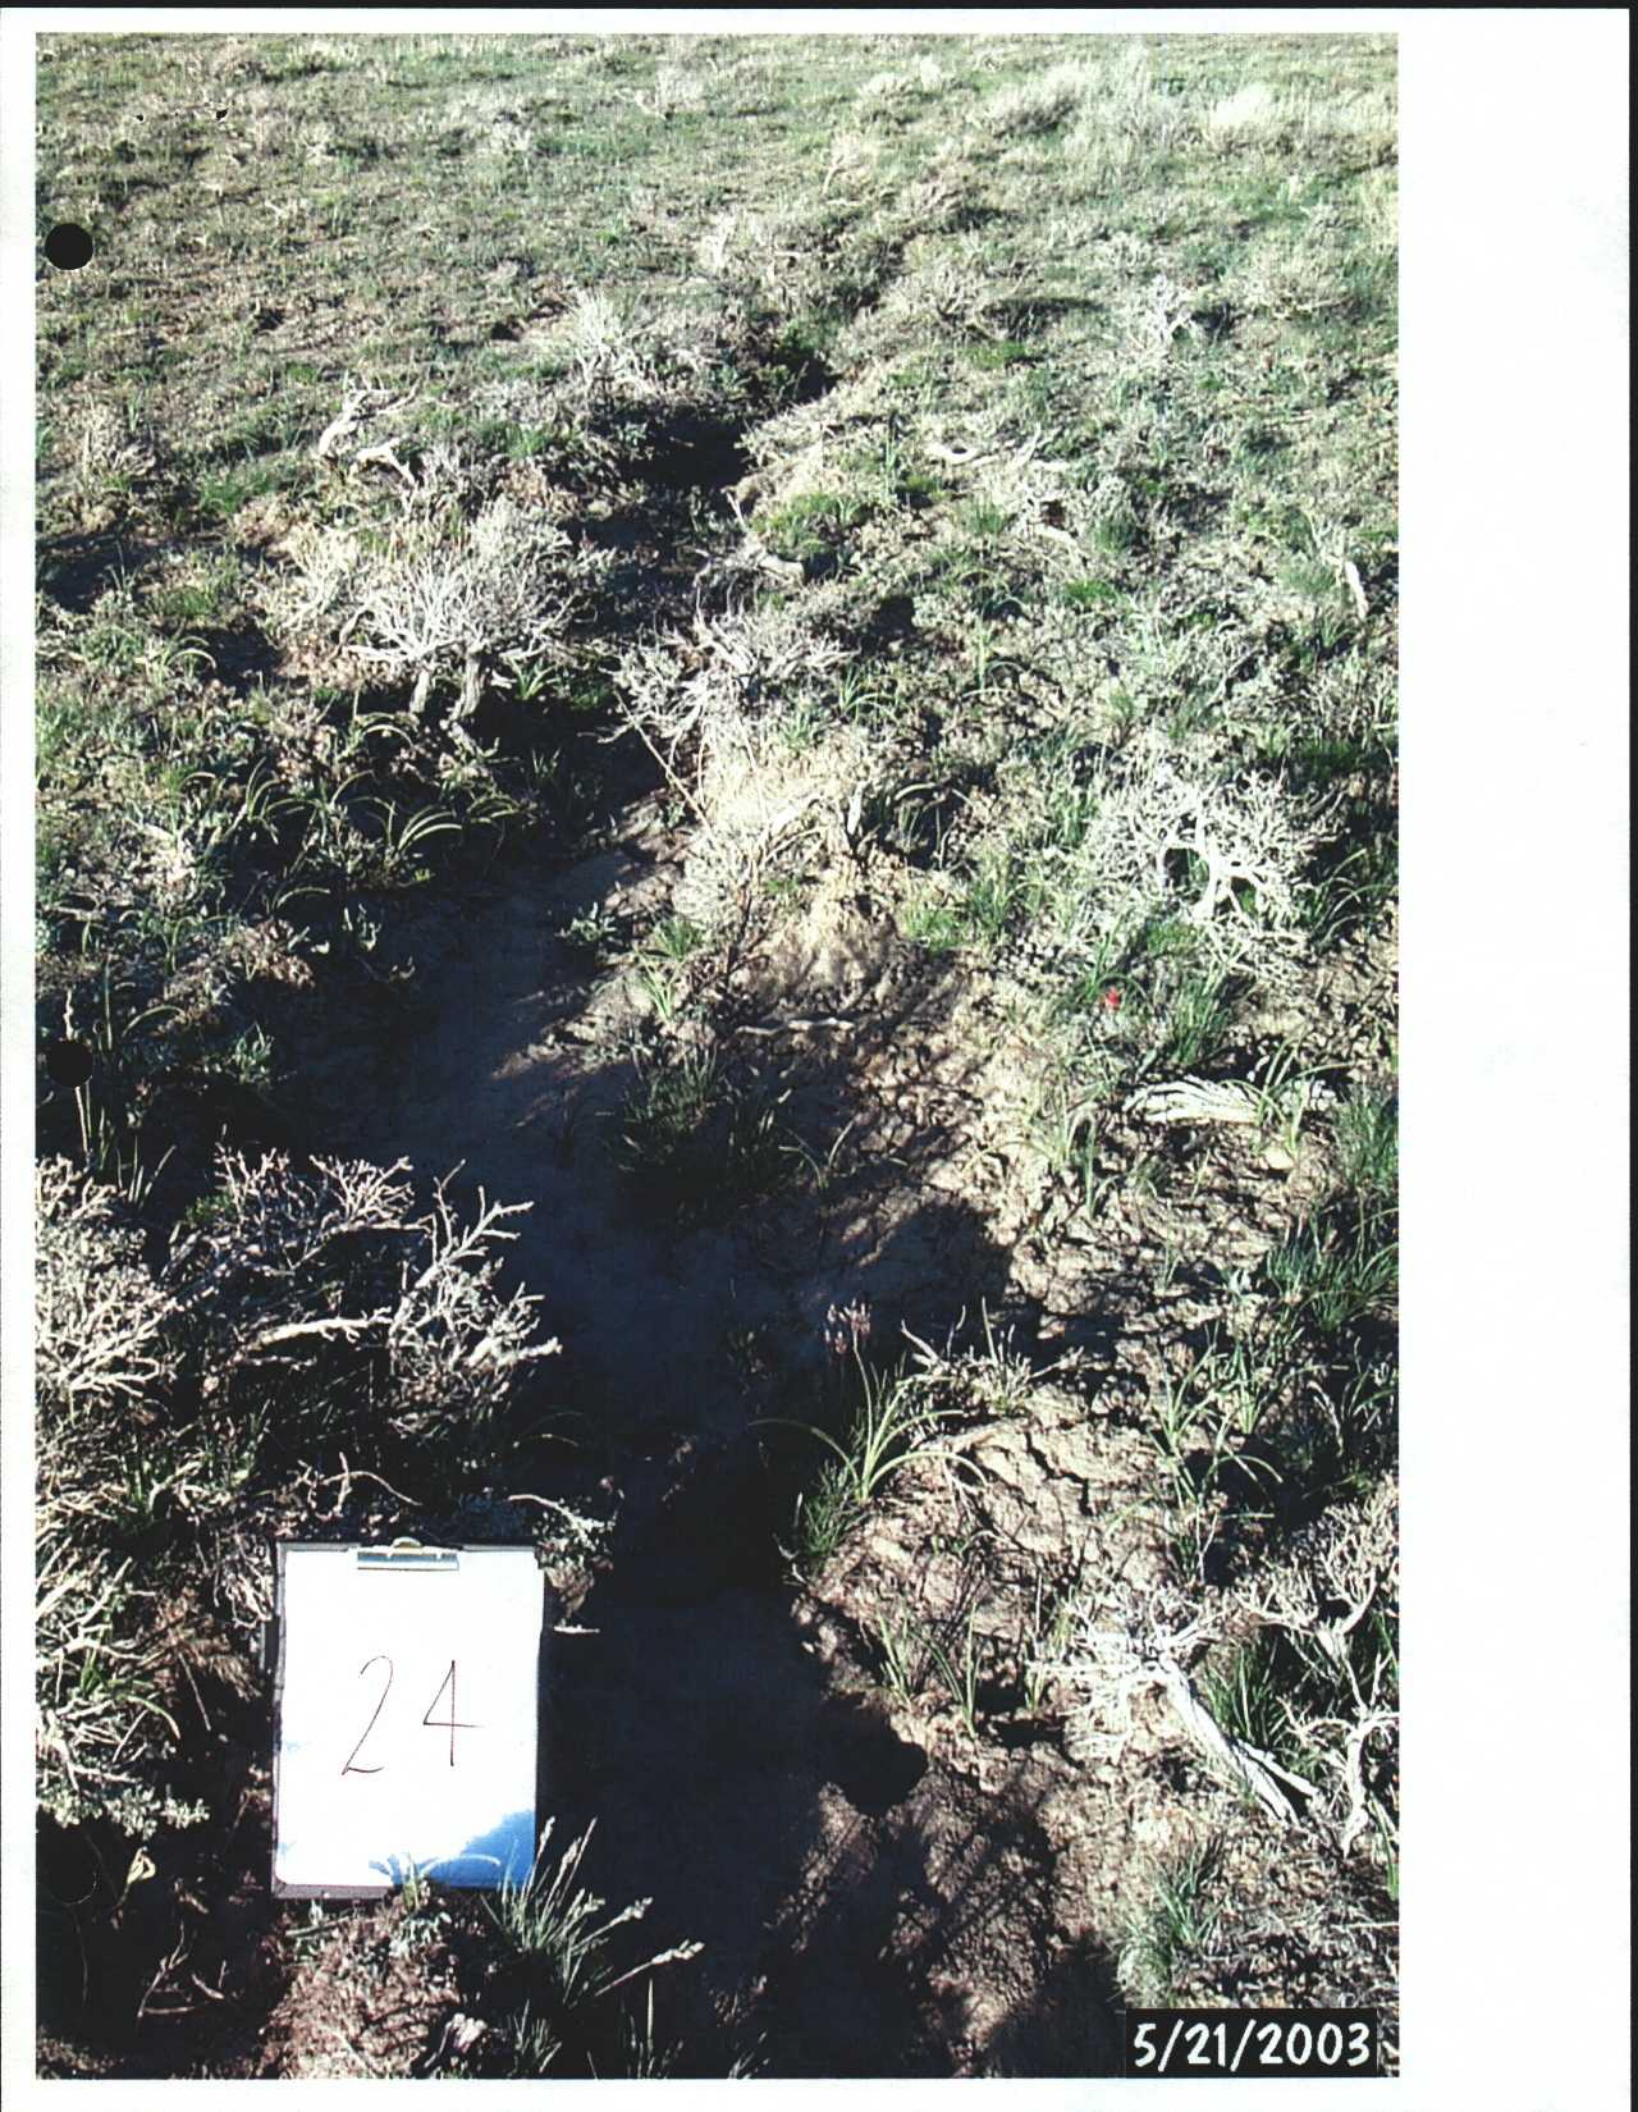
24

Dimensions (in feet): This crack is 159 feet long, and appears to have been a pretty wide crack when it was a crack (it is filled in now).

An example of a crack that has completely healed.
